BULLETIN 34076 MWM ENGINE SYSTEM INLET MANIFOLD INTERFERENCE

Date: 11 October 2016

BULLETIN MWM Inlet interference with Exhaust Manifold.

GE Mining advises the following in relation to the MWM Diesel Engine System MDR 114056 (DES) installed on GE MineCruiser MK7s, Graders & Personnel & Equipment Transporters (PETs).

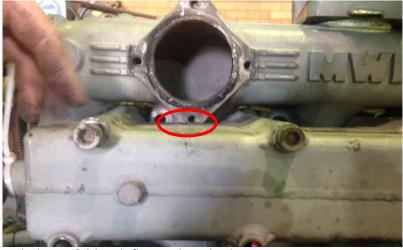
Interference between the inlet manifold and exhaust manifold has been observed on two MineCruiser MK7s fitted with MWM Diesel Engine Systems. In one occurrence the interference caused the failure of the inlet manifold at the welded joint that connects the inlet manifold to the air inlet flame trap. An open failure of an Ex DES component compromises the explosion protection.

Dimensional irregularities of fabricated components may cause interference under the flange or adjacent port chambers. The design requires clearance between these components to ensure that joints can be securely sealed. Assembly with interference will subject the components to contact forces that may cause leakage or fatigue failures.

Failed Manifold with flange detached. Circled region shows the location of interference between inlet and exhaust manifolds.

GE recommend that MWM engine systems that are in service be inspected at the next opportunity to ensure that there is no interference between the inlet and exhaust manifolds.

GE recommend that an inspection be made on assembly of components (typically code D overhaul) to ensure that there is clearance between these components upon assembly of the engine system. Components should be inspected for signs of contact or weld cracking prior to re-assembly.

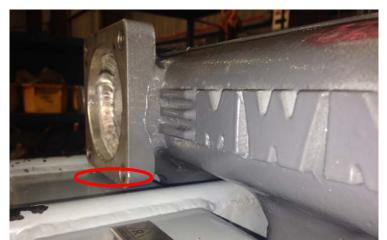
Inlet manifold flange & port chamber adjacent to exhaust manifold – Clearance should be observed in area indicated
