PRODUCT BULLETIN 36138

MWM Engine Failures and Preventative Maintenance

Date: 16-12-2021

Prepared by: Australian Mining Equipment

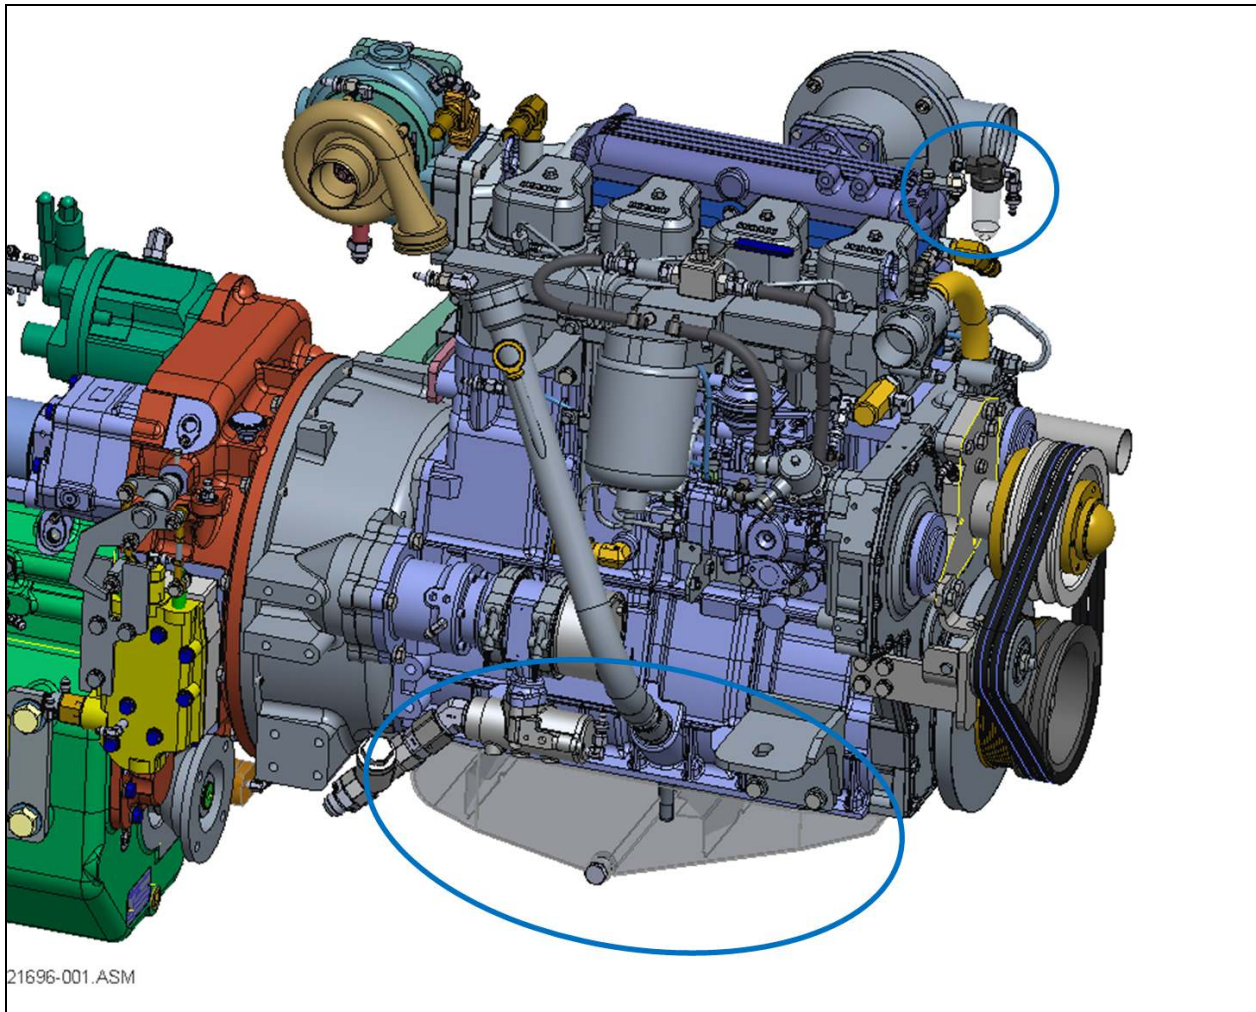
Engine and transmission assembly with Upgraded sump / Water pump weep hole reservoir
