PRODUCT BULLETIN 36138

Predator Front Frame Lifting Modification

Date: 08-06-2022

Prepared by: Cougar Mining Equipment

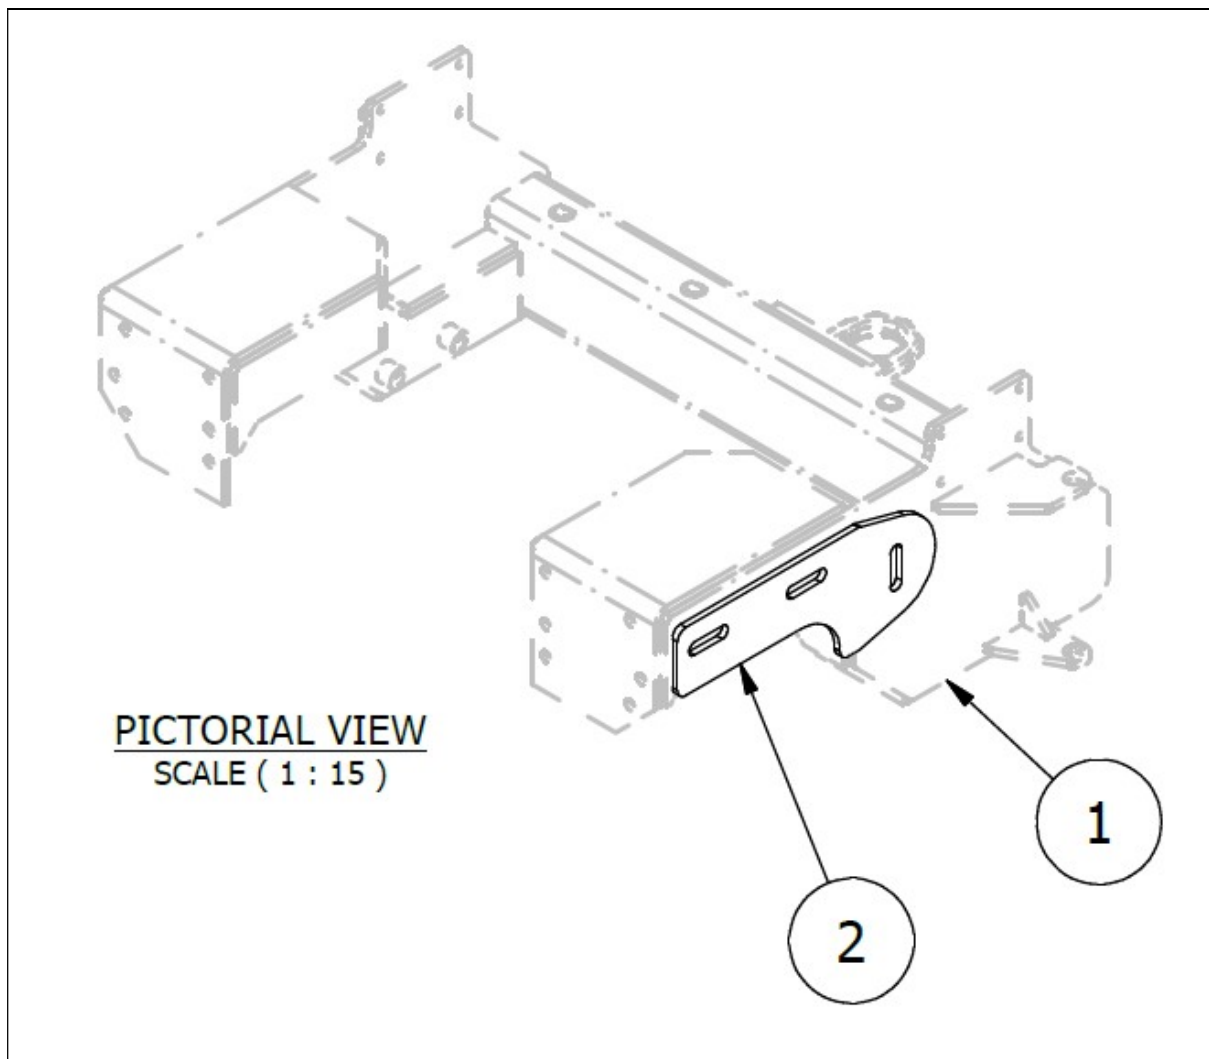
Figure 1: Front Frame Fatigue Life Improvement

The load factors of the front chassis frame have been reviewed for the load case of lifting the front of the vehicle onto stands. After detailed analysis, it has been established there may be a fatigue concern in the main side plates of the front frame, when subjected to ongoing lifting and lowering. No incidents or fatigue cracking have yet been observed or reported in the front frame.

To address concerns with potential fatigue cracking in the future, a strengthening doubler plate design has been developed and analysed as shown in **Figure 1**. The addition of the doubler plate reduces bending stress by approximately 40%

- Implement ongoing inspection on predator front frames if not already in the mines maintenance schedule
- Where the machine is lifted onto stands via the front frame, make arrangements with Cougar Mining Equipment for installation of doubler plate addition as per the depiction in figure 1. A lifting procedure for performing this task is also available from CME.
