Ref Document – EB0008 issue 01  
Date May 25, 2006

## **PRODUCT INFORMATION BULLETIN**

### **STEERING COLUMN INTEGRITY**

PJB Minecruisers and Nippers.

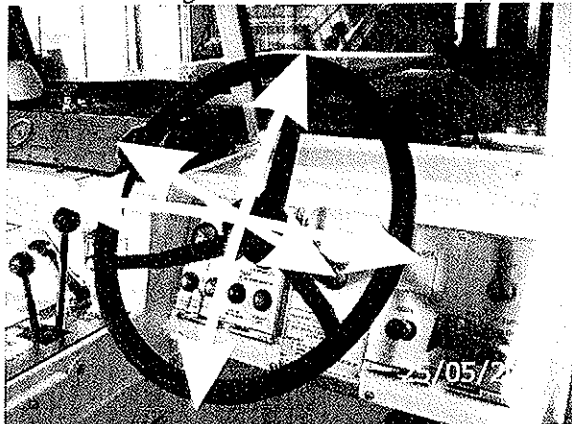
A PJB Minecruiser was being driven along a mine roadway. The vehicle struck a large bump. The resulting jolt caused the operator to apply a force to the rim of the steering wheel sufficient to cause the wheel and the steer shaft to lift out of the steer valve resulting in loss of steering.

Subsequent inspection has revealed the bearing in the wheel end of the steering column had collapsed. It is not known whether the bearing had collapsed prior to the vehicle striking the bump or as a result of the force applied by the operator.

The manufacturer of the steering column advises the steering column should not be exposed to an axial force greater than 1kN (=100kg). The bearing is not designed to be maintained or replaced and is sealed for life.

- 1) Inspect for play in the bearing on a yearly basis by gently shaking the steering wheel in the directions shown below. If significant play is detected the steering column should be replaced.
