Ref Document – EB0011 issue 01

PRODUCT INFORMATION BULLETIN

PJB NIPPER - STARTUP DELAY

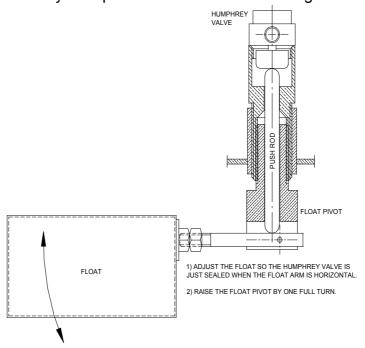
When attempting to restart the engine there can be a significant delay while the exhaust conditioner safety chamber is refilled with water. During that time the water lift pump is consuming air and consequently reducing the air pressure in the main air receivers. On occasions the system pressure is reduced to the point where the remaining pressure is insufficient to start the machine.

1) Set the safety float position as shown on the diagram below.
