Ref Document – EB0003 issue 01
Date 24-6-04

PRODUCT SAFETY BULLETIN

ZF Steer Axle

PJB Minecruiser, Mk 4.5

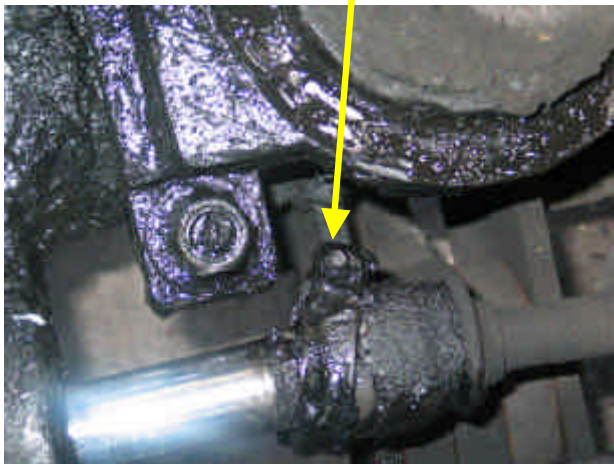
A replacement steering link had been incorrectly fitted to a Mk4.5 Minecruiser steer axle by others. The link had been fitted such that the clamp near the ball joint rubber cover was rotated 180° from its normal position allowing it to contact the axle mounting saddle and hence restrict the steering angle of the axle on that side.

The limiting of the steer angle resulted in the machine running wide in a corner and impacting the rib. Consequently the front passenger and a rear passenger were injured and the machine was damaged.

All Minecruisers fitted with ZF steer axles should be inspected to confirm correct fitment of the steering joint clamp. The incorrect fitment is shown in Photo 1 while the correct arrangement is shown in photo 2.
