## PRODUCT TECHNICAL BULLETIN 36307 GRADER PARK BRAKE PINION SHAFT – DESIGN IMPROVEMENT

**Date:** Jan 2024  
**Issue:** A (release)  
**Prepared for:** Industry/ End Users

**Applicable machines:** Graders installed with mechanical park brake legacy pinion shaft 7-090909-700  
(serial numbers 014 – 039)

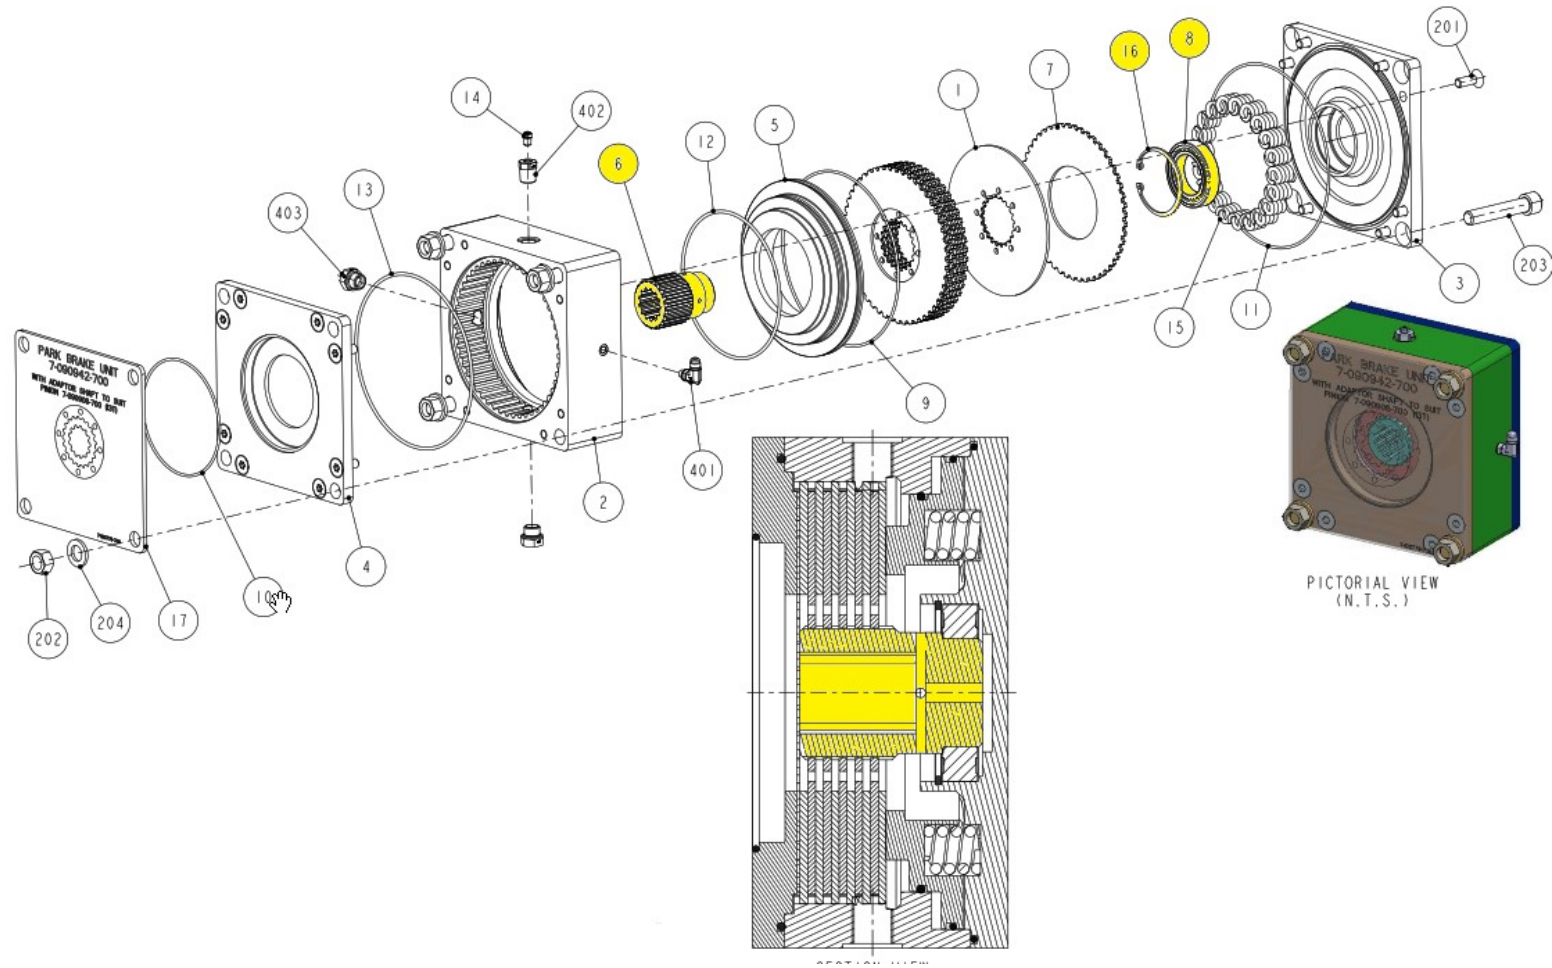
The Pinion adaptor shaft in park brake assembly 7-090942-700 is no longer required as the pinion shaft direct engages the brake discs – refer figure 1

**Figure 1: Original Park brake assembly 7-090942-700 indicating spline adaptor shaft (no longer required)**

NOTE: when installed with the new pinion shaft, this adaptor is not required, if ordering a new brake assembly to suit the upgraded pinion, it can be ordered as **7-090942-700U** to be supplied without the spline adaptor shaft.

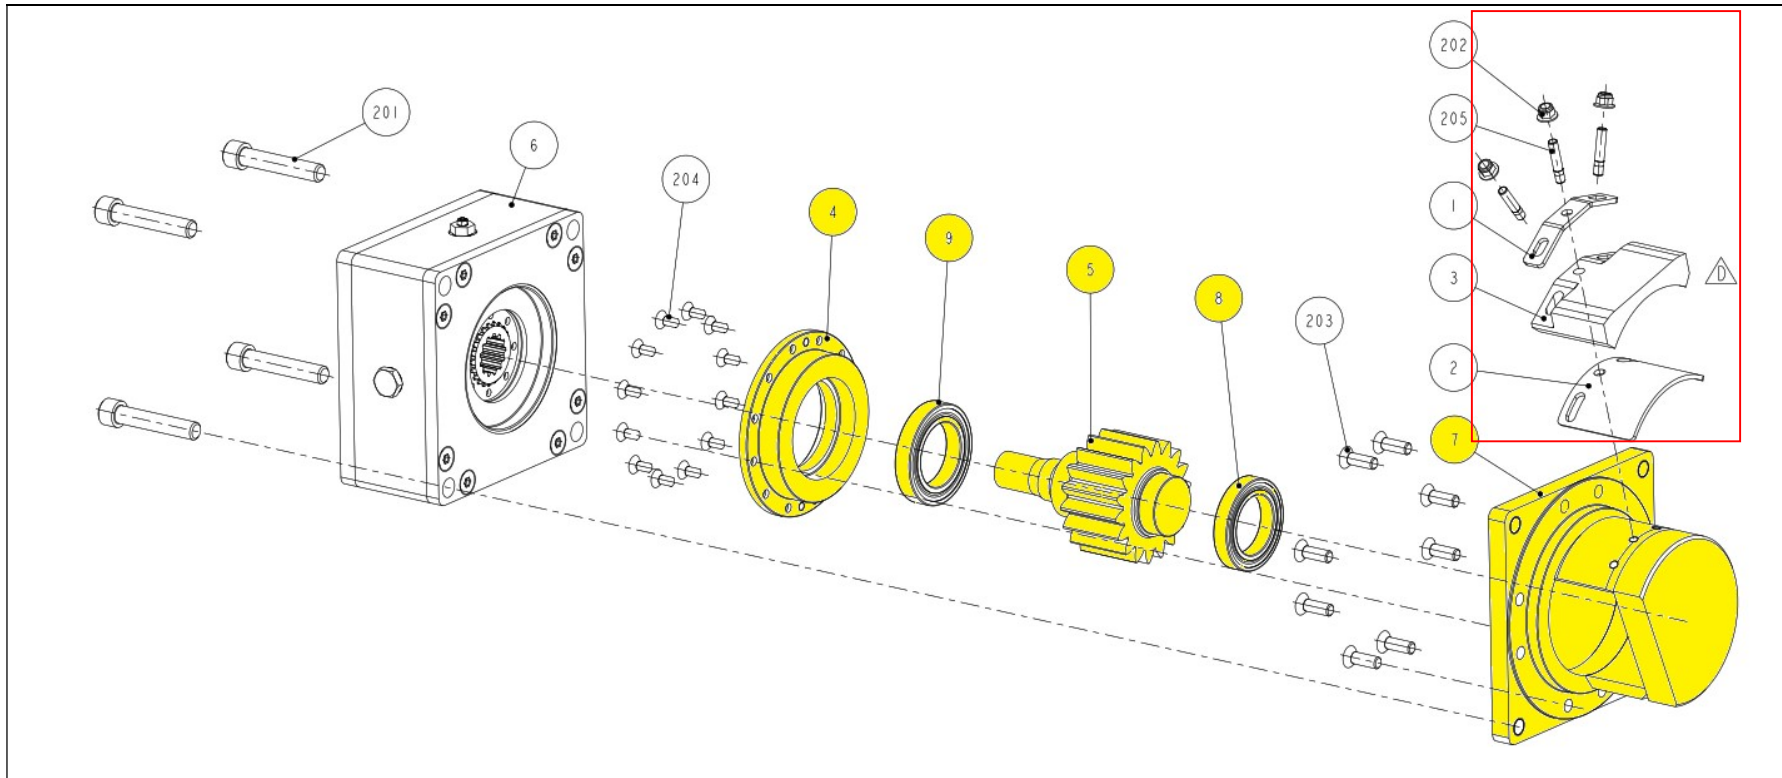
**Figure 2: The above indicated components are replaced for the pinion upgrade**

NOTE: The upgraded Pinion shaft design also includes an improved chain guide as indicated by items the red box. The chain guide has additional fasteners to prevent slippage of the chain guide.

- Upgrade machines installed with the legacy park brake pinion shaft to the later improved design. Contact Cougar Mining Equipment to make arrangements for this work.  
Note: If park brake Pinions are not upgraded to the later design, the original pinion shaft should be non-destructively inspected via magnetic particle inspection at a frequency not exceeding 2000hrs or 2 years.
