# **BULLETIN 34110**

## **MWM EXHAUST SURFACE**

### **TEMPERATURE**

## **BULLETIN** MWM Engine System Surface Temperature advice.

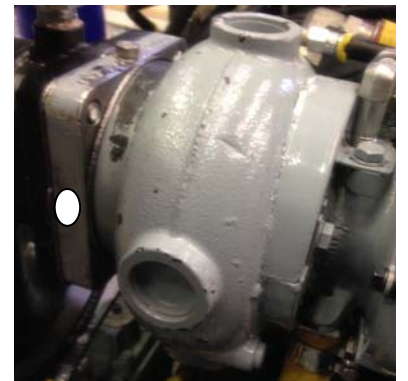
In the course of routine testing, a small area on the turbo/exhaust pipe adaptor plate has been identified to be over-temperature. The temperature has been found to reach 152C in an area approximately 20 mm in diameter. An occurrence has been identified on two GE Graders during torque stall testing. A test on a MineCruiser has not presented the same over temperature result. Note the engine system is common to both machines.

As an interim measure, GE recommends that the surface temperature of machines with MWM engine systems be surveyed in the location identified below, and a site specific risk assessment be made.
